**Flood Control Project Maintenance  
Levee Inspections**  
**LMA District Cover Sheet**  
**Spring 2017 Levee Inspection Results**

**Reclamation District No. 0784 Plumas Lake**

**Spring 2017 Levee Inspection Results**

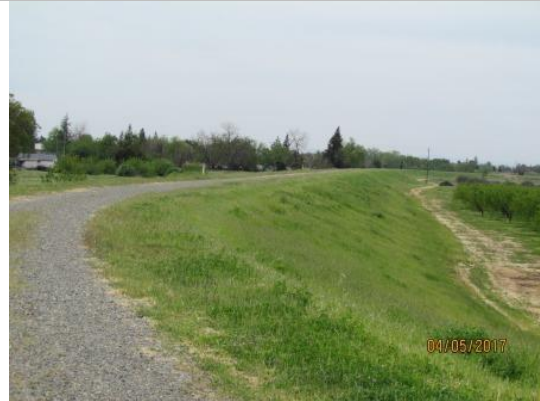
Photo 1 of 1 : SP\_2017\_RD0784\_178\_3\_20170410\_00006.jpg

View looking downstream of annual grasses, Spring 2017.

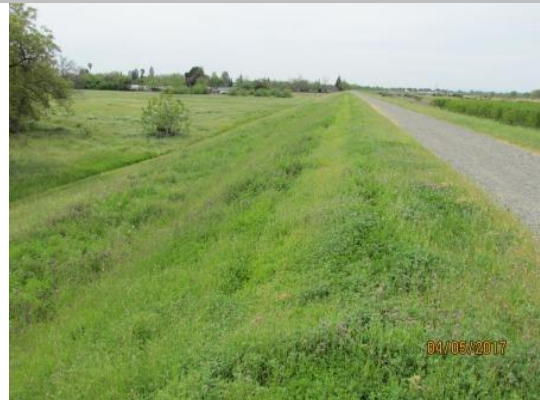
Photo 1 of 1 : SP\_2017\_RD0784\_178\_2\_20170410\_00007.jpg

LM Start	0.04	Rating **	M	Issue No.	2
LM End	2.20	Issue Type +	Ma	Location *	LS
Category	Earthen Levee			GPS Latitude/Longitude	
				Start	End
Item	Vegetation			39.134450 °	39.125942 °
				-121.552668 °	-121.588627 °
DWR ID	DWR_RD0784_01_s_2017_2				
Comment Code					
V1 : Control annual grass and weeds on the levee slopes and easements.					
Inspector Comment					
Maintain annual grasses, Spring 2017.

View looking downstream of annual grasses, Spring 2017.

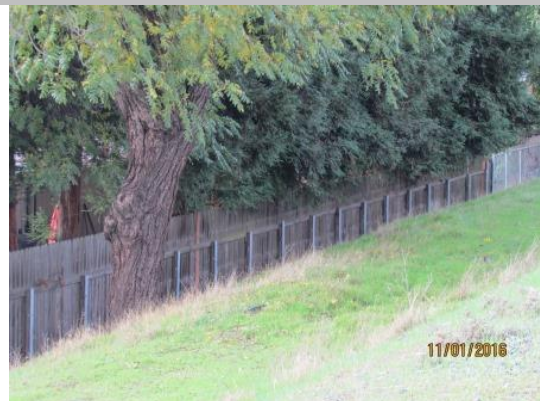
Photo 1 of 1 : SP\_2017\_RD0784\_178\_12\_20170316\_00001.jpg

LM Start	0.51	Rating **	M	Issue No.	12
LM End	1.00	Issue Type +	En	Location *	LS
Category	Earthen Levee			GPS Latitude/Longitude	
				Start	End
Item	Encroachments			39.131558 °	39.129475 °
				-121.560668 °	-121.569209 °
DWR ID	DWR_RD0784_01_f_2012_12				
Comment Code					
FE : Fence					
Inspector Comment					
Fences are found within the 10 feet of levee easement .

Fences were found on the landside toe of the levee looking downstream. Fall 2016.

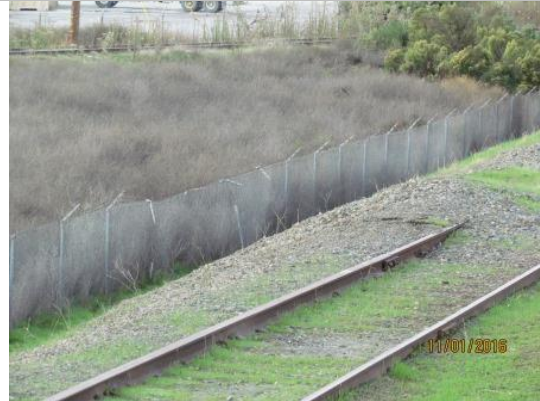
Photo 1 of 1 : SP\_2017\_RD0784\_178\_13\_20170316\_00002.jpg

This photo shows a fence near the levee toe on the landside looking downstream. Fall 2016.

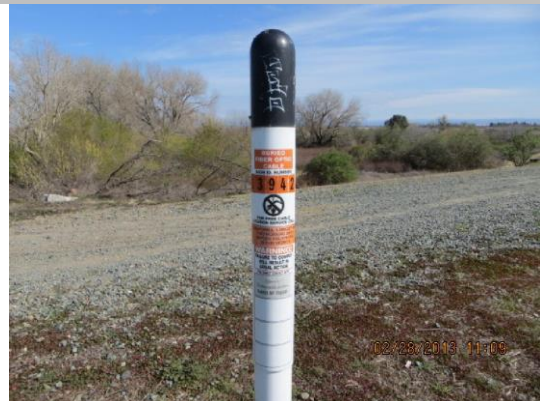
Photo 1 of 3 : UCIP\_SP\_2017\_50677\_54402.jpg

Comment Code					
Inspector Comment					
FS_ID:50677 DS_ID:18552 EP_NO: N/A Repair Type: Non-Urgent Crossing Status: Indicator Found UCIP Comments: 11/15/2016 - Crossing is still Non-Urgent due to the possibility that the pipe is unpermitted. The crossing will be downgraded when owner provides permit or CVFPB enforcement resolves the issue. (DWR UCIP - thatch)11/01/2015 - Letter requesting permit or to provide permit sent to owner Century Link, 700 W. Mineral Avenue, Rm D 27.34, Littleton, CO 80120 on 2/18/2014. Pending CVFPB enforcement on utility crossing owner. Requesting DWR inspector to change the status of this issue to "No Action Needed" (P. Meagher - RD784) 02/28/2013 - No permit identified for this crossing. Need to determine if owner has permit. (W.Wylie UCIP Inspector). FIELD_STRUCT_DESC: Fiber Optic Communication lines cross levee. Diameter unknown. FS Date: 9/11/2015 9:08:00 AM

Marker on east side of Rail/WS of Levee.

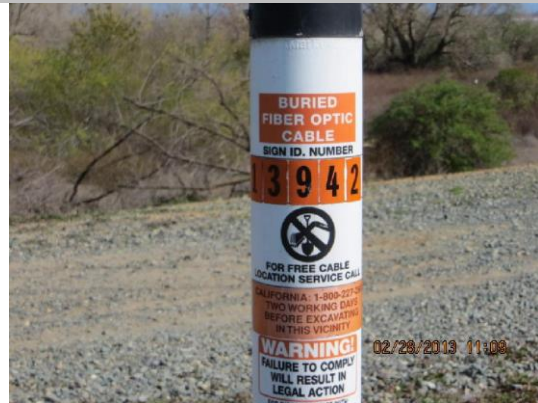
Photo 2 of 3 : UCIP\_SP\_2017\_50677\_54401.jpg

Marker on east side of Rail/WS of Levee.

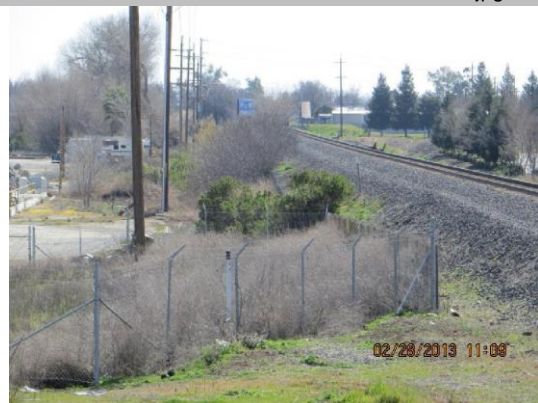
Photo 3 of 3 : UCIP\_SP\_2017\_50677\_54400.jpg

Marker on East side of Rail/LS of levee.

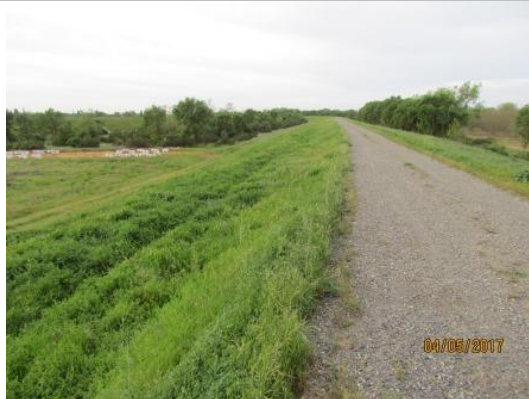
Photo 1 of 1 : SP\_2017\_RD0784\_531\_1\_20170410\_00002.jpg

View looking downstream of annual grasses, Spring 2017.

LM Start	0.04	Rating **	M	Issue No.	2
LM End	2.54	Issue Type +	Ma	Location *	WS
Category	Earthen Levee			GPS Latitude/Longitude	
				Start	End
Item	Vegetation			39.125324 °	39.090307 °
				-121.588604 °	-121.584686 °
DWR ID	DWR_RD0784_02A_s_2017_2				
Comment Code					
V1 : Control annual grass and weeds on the levee slopes and easements.					
Inspector Comment					
Maintain annual grasses, Spring 2017.

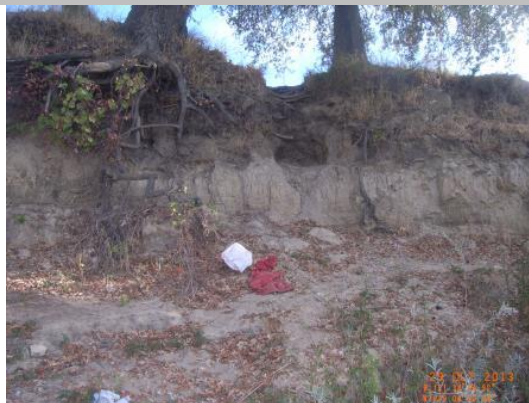
Photo 1 of 1 : SP\_2017\_RD0784\_532\_1\_20170316\_00001.jpg

Comment Code					
Inspector Comment					
2003 - Bank is near vertical. Identified as a Potentially Critical site. 2004 - Eddy flow off downstream end of Modesto formation eroding the fluvial sediments. 2005 - Some new slumping. Actively eroding but berm width is greater than 50 ft. 2006 - Downgraded to regular erosion site. Still actively eroding. Large old rotational failures in high bank on the downstream end. 2008 - Removed from inventory due to wide berm width does not meet criteria for an erosion site. 2010 - Added back to the inventory after 10 ft of bank erosion in the winter 2009 storm. Steep vertical face. 2011 - Bank has retreated an additional 2.5 ft from last year. New tree popouts and erosion throughout the site. 2012 - Site continues to worsen with new tree popouts and many sections of new erosion. 2015: Last observed in 2013. [2015 Site ID: FHR_17-8_L]

USACE 2013 Photo #1

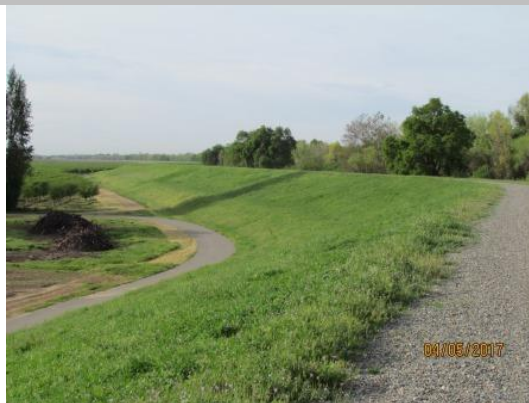
Photo 1 of 1 : SP\_2017\_RD0784\_532\_2\_20170410\_00003.jpg

LM Start	9.19	Rating **	A/W	Issue No.	2
LM End	12.86	Issue Type +	Ma	Location *	LS
Category	Earthen Levee			GPS Latitude/Longitude	
				Start	End
Item	Vegetation			39.006792 °	38.954616 °
				-121.577790 °	-121.574700 °
DWR ID	DWR_RD0784_02B_s_2017_2				
Comment Code					
V1 : Control annual grass and weeds on the levee slopes and easements.					
Inspector Comment					
Annual grasses are less than 6" tall at time of inspection, Spring 2017.

View looking downstream of annual grasses, Spring 2017.

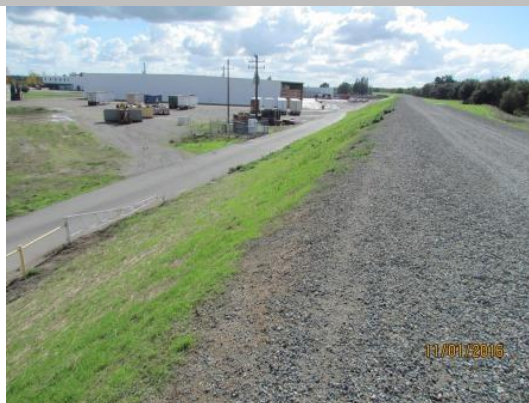
Photo 1 of 1 : SP\_2017\_RD0784\_532\_6\_20170316\_00002.jpg

LM Start	9.21	Rating **	M	Issue No.	6
LM End	9.31	Issue Type +	En	Location *	LS
Category	Earthen Levee			GPS Latitude/Longitude	
				Start	End
Item	Encroachments			39.006523 °	39.005235 °
				-121.577843 °	-121.578286 °
DWR ID	DWR_RD0784_02_f_2012_6				
Comment Code					
MA : Material					
Inspector Comment					
Un-permitted paving at levee toe. Fall 2016.

View looking downstream on the land side of un-permitted paving. Fall 2016.

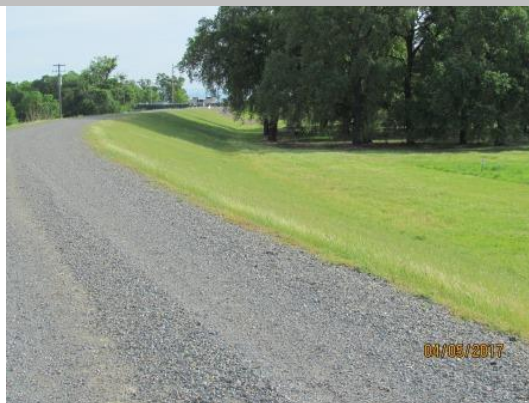
Photo 1 of 1 : SP\_2017\_RD0784\_533\_2\_20170410\_00001.jpg

LM Start	2.45	Rating **	A/W	Issue No.	2
LM End	3.20	Issue Type +	Ma	Location *	WS
Category	Earthen Levee			GPS Latitude/Longitude	
				Start	End
Item	Vegetation			38.970853 °	38.974686 °
				-121.547385 °	-121.535309 °
DWR ID	DWR_RD0784_03A_s_2017_2				
Comment Code					
V2 : Remove the wild growth other than native grasses from the levee slopes.					
Inspector Comment					
Annual grasses are less than 6" tall at time of inspection, Spring 2017.

View looking upstream at annual grasses, Spring 2017.

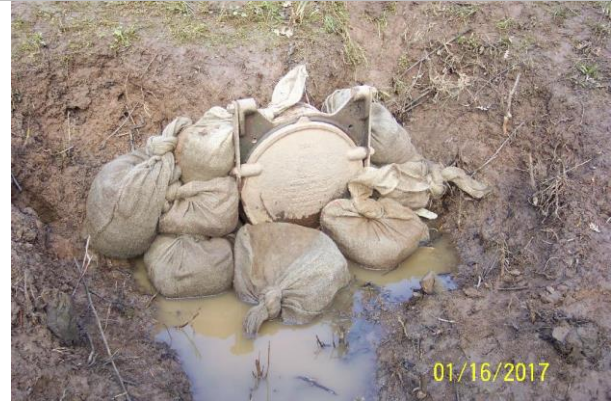
Photo 1 of 3 : UCIP\_SP\_2017\_51717\_76618.jpg

FS\_ID:51717  
DS\_ID:18627  
EP\_NO: N/A  
Repair Type: Urgent  
Crossing Status: Found  
UCIP Comments: 04/13/2017 - Spoke to LMA representative, P. Meagher, regarding the status of this crossing. The report has been updated to indicate vegetation has been cleared from WS outlet and LS inlet. The crossing remains Urgent--WS pipe collar is rusted out on the bottom. Recommend internal pipe inspection to determine pipe integrity through the levee. Owner will need to coordinate with the CVFPB to address issue. (O. Magana - DWR UCIP) 01/16/2017 - Landowner who utilizes this pipe reported to RD784 staff on 1/11/2017 that he suspected this pipe at the waterside flap gate ring area was rusted out at the bottom. After investigating, we could see what was reported is correct. Sandbags have been temporarily placed around the 2" +/- gapped area underneath the flap gate ring. A permanent solution is anticipated to be completed in the next 3 to 6 months. The plan is to pour a concrete ring / headwall around the open corroded pipe end. Photos attached. (P. Meagher - RD784) 11/04/2016 - Flap gate on waterside has been cleared again as of 10/17/2016. The LS inlet area has been cleared as of 9/21/2016. See updated photos attached. (P.Meagher - RD784) 09/22/2016 - vegetation at inlet of pipe has been cleared by owner. photos added showing pipe inlet. (T. Hatch - DWR UCIP) 08/09/2016 - vegetation partially obscuring outlet on WS. Heavy vegetation on landside (LS) limiting inspection of inlet. Owner asked by RD0784 to clear vegetation and debris. (T. Hatch - DWR UCIP) 11/1/2015 - Flap Gate has been cleared as of 12/9/2014 and again during summer of 2015 (P. Meagher/RD0784) 2/27/2013 - Flap gate blocked by vegetation on WS toe. Unable to locate inlet. (W. Wylie - DWR UCIP)

Sandbags temporarily placed in front of flapgate.

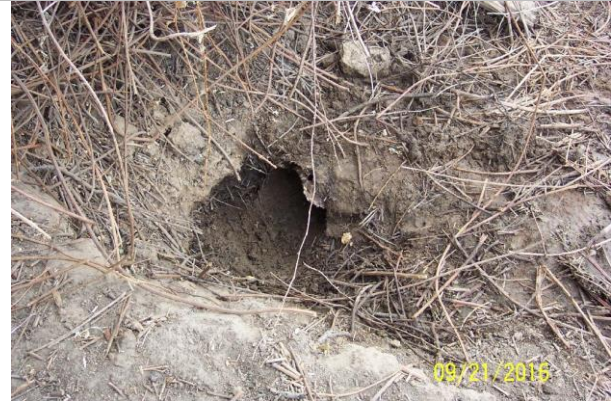
Photo 2 of 3 : UCIP\_SP\_2017\_51717\_75974.jpg

View of the inlet of the pipe on the LS after vegetation was removed

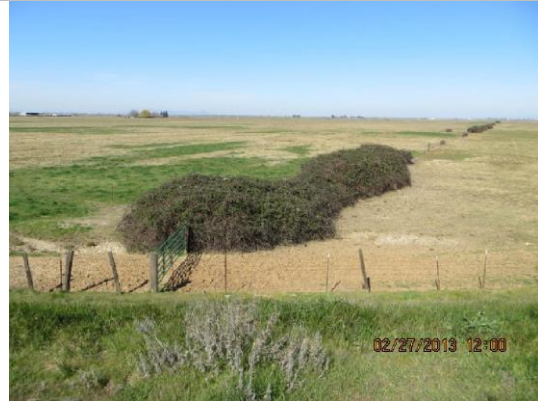
Photo 3 of 3 : UCIP\_SP\_2017\_51717\_54223.jpg

Unable to locate inlet due to blackberry overgrowth on LS toe.

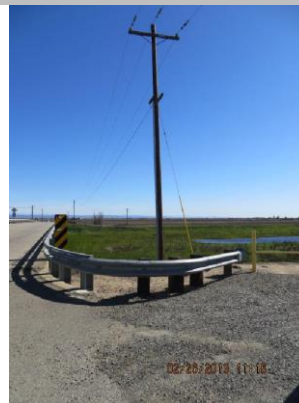
Photo 1 of 3 : UCIP\_SP\_2017\_46600\_54244.jpg

LM Start	3.59	Rating **	M	Issue No.	5
LM End	3.59	Issue Type +	En	Location *	LS
Category	Supplemental			GPS Latitude/Longitude	
				Start	End
Item	DWR UCIP Field Study			39.026347 °	39.026347 °
				-121.542343 °	-121.542343 °
DWR ID					
Comment Code					
Inspector Comment					
FS_ID:46600 DS_ID:22686 EP_NO: N/A Repair Type: Non-Urgent Crossing Status: Found UCIP Comments: No permit identified for crossing. FIELD_STRUCT_DESC: Communication line through the levee at unknown depth on downstream side of bridge. FS Date: 9/11/2015 9:25:57 AM

Communication line at base of JP on WS slope.

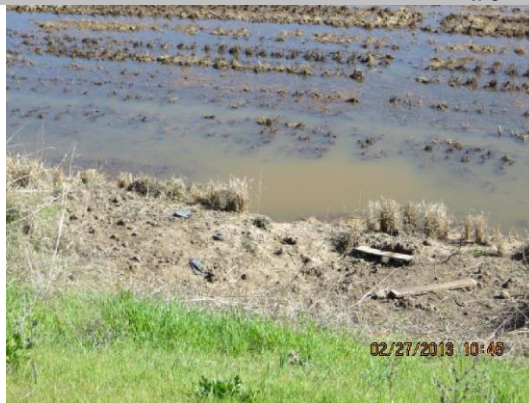
Photo 2 of 3 : UCIP\_SP\_2017\_51719\_54248.jpg

Debris covered inlet on LS toe.

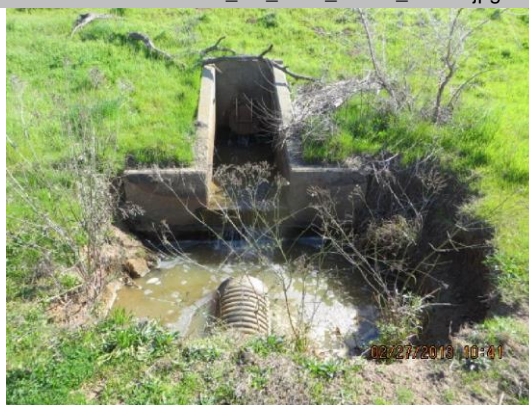
Photo 2 of 3 : UCIP\_SP\_2017\_51707\_54253.jpg

Concrete U-shaped headwall on WS toe with Flap gate showing erosion at outlet.

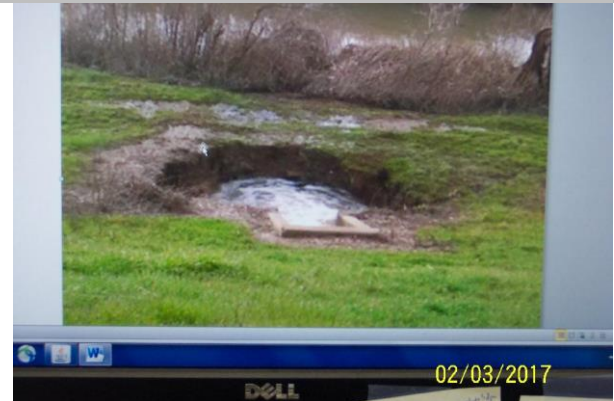
Photo 3 of 3 : UCIP\_SP\_2017\_51707\_76774.jpg

After photo after excess pipe was cut off. Actual photo date was 1/31/2017

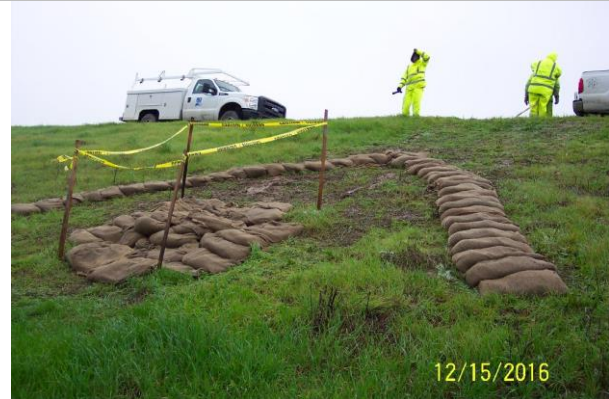
Photo 2 of 3 : UCIP\_SP\_2017\_51715\_76309.jpg

WS view: Sink hole filled in with sandbags and "V" shaped diversion dam built to help divert rainwater.

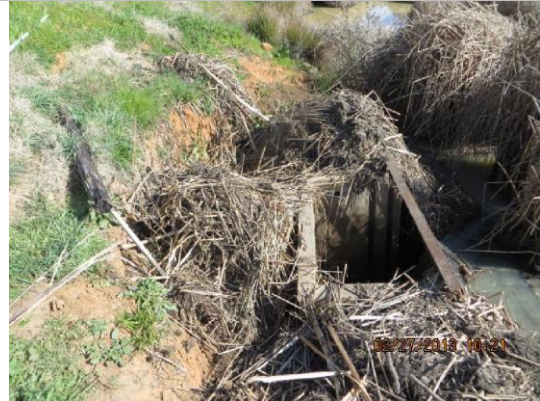
Photo 3 of 3 : UCIP\_SP\_2017\_51715\_54254.jpg

Erosion and debris from Beaver activity.

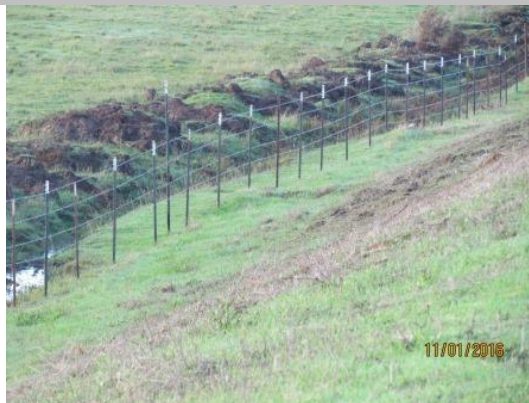
Photo 1 of 1 : SP\_2017\_RD0784\_182\_5\_20170316\_00001.jpg

View of fence along the landside toe looking downstream. Fall 2016.

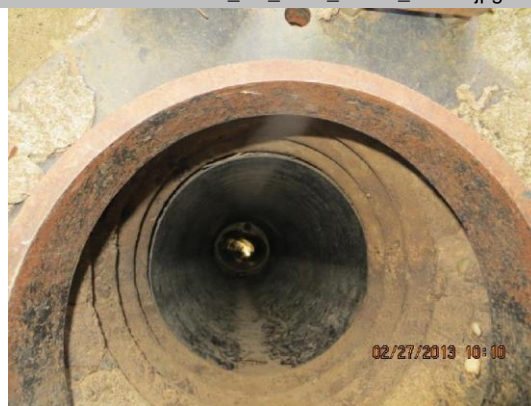
Photo 2 of 3 : UCIP\_SP\_2017\_51714\_54262.jpg

Pipe showing sliplined PVC insert. some erosion of PV at outlet and it may be disjointed internally.

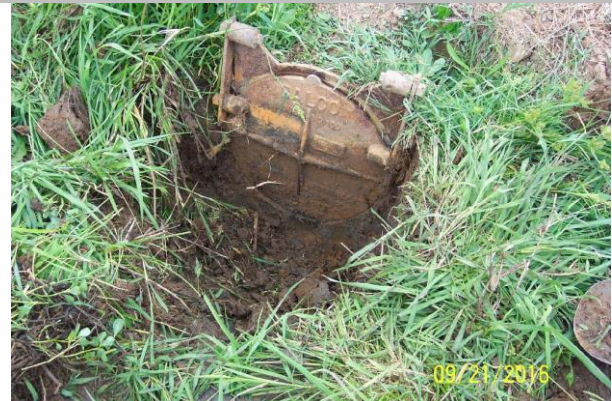
Photo 1 of 3 : UCIP\_SP\_2017\_51712\_76147.jpg

Flap gate on the WS toe is exposed

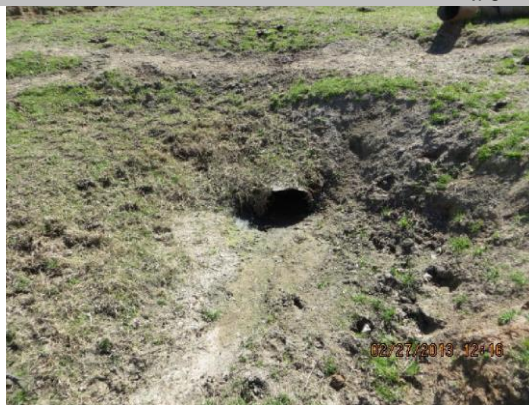
Photo 2 of 3 : UCIP\_SP\_2017\_51716\_54268.jpg

Partially clogged inlet pipe at LS toe.
